MARYLAND GEOLOGICAL SURVEY
Merryman Hall
The Johns Hopkins University
Baltimore, Maryland 21218
(301) 235-0771

COUNTIES (MD/PA) HARFORD/YORK
M&D milestone no. 25 (27) (crownstone)
MHT-HSI no. HA-118
MAGI no. 1301184234
PROTECTED/ENDANGERED/MISSING

FIELD SHEET: MASON & DIXON LINE, MARYLAND-PENNSYLVANIA BOUNDARY MARKER SURVEY

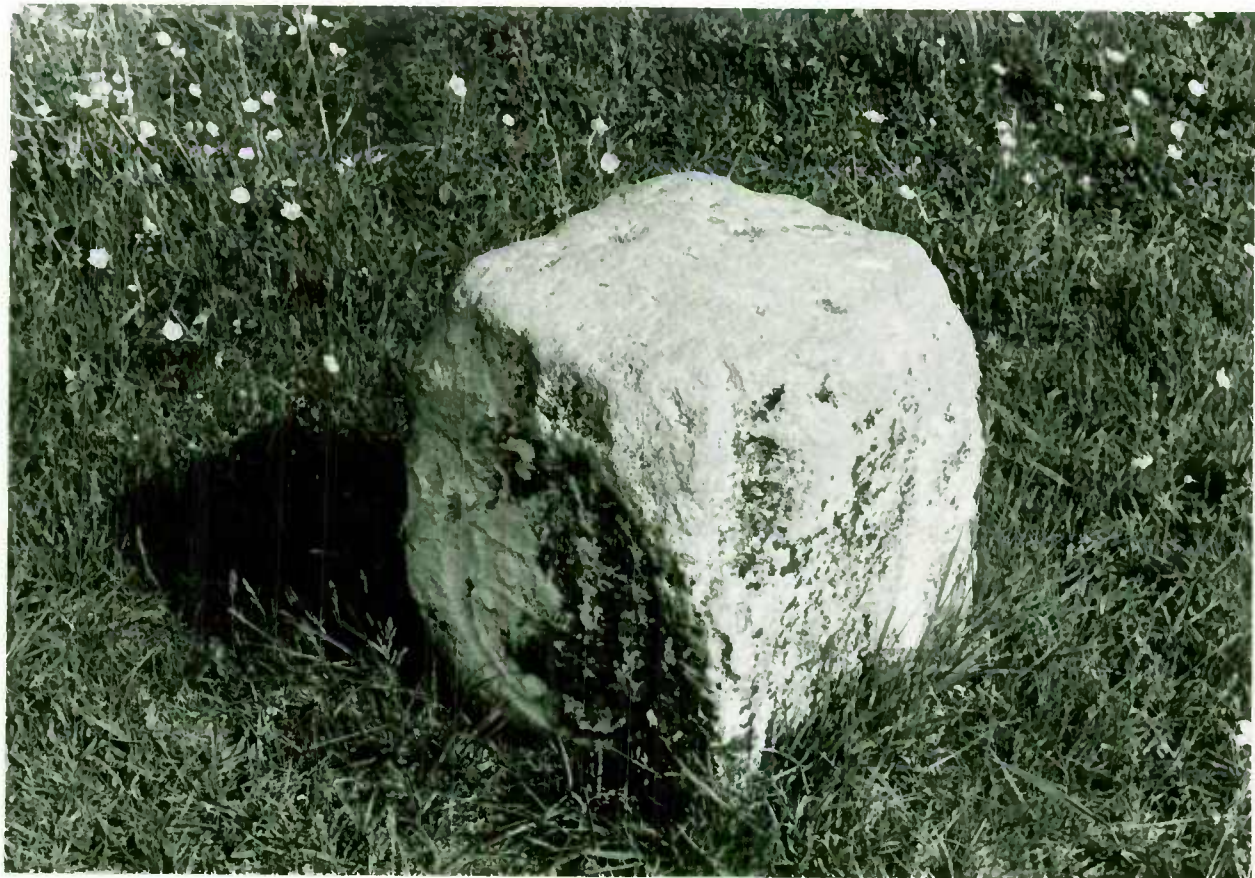
PHOTO: STEPHANIE PATTERSON 310 50 (LEG 7 25A)

N face (PA): 11 1/2" wide x 12 1/4" high; Penn coat of arms intact, no fluting or margins;
chips all edges & corners; badly weatherworn & scarred

W face: 11 1/2" wide x 13" high; no fluting or margins; chips all edges & corners;
badly weatherworn & scarred

MASON & DIXON WEST LINE MILESTONE NO. 25 (KIDWORTHY) (27)
 NEW CORNER (PEN) COAT OF ARMS (—)

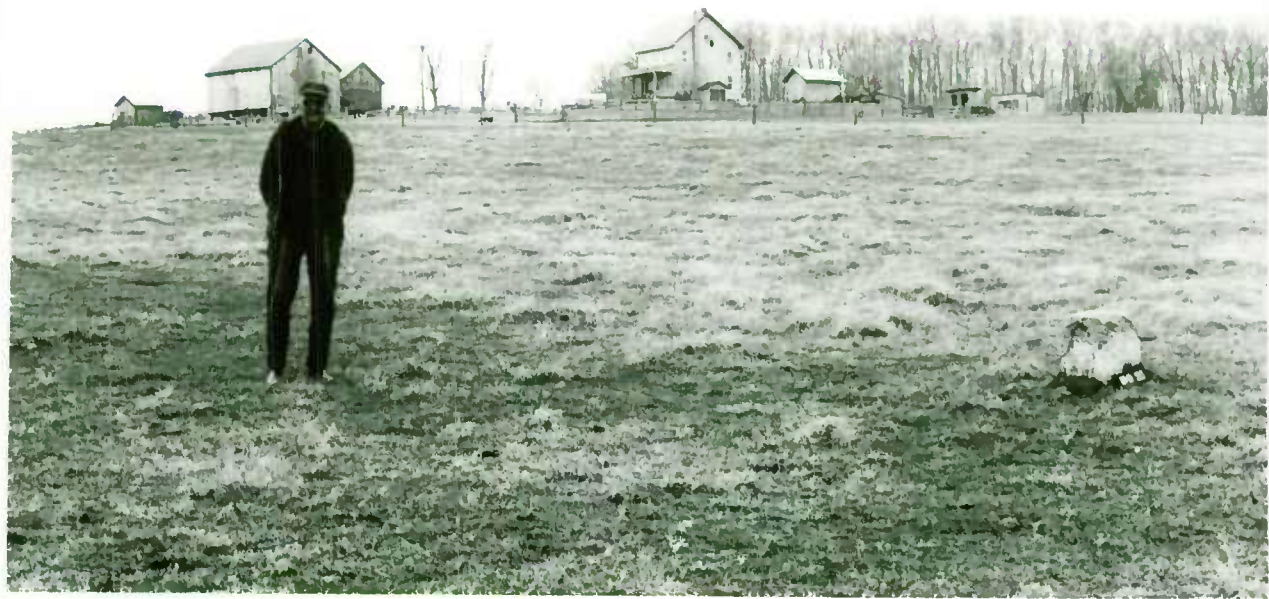
PHOTO: ALICE MARTIN 12/2/19 (1919.15.24)

MASON & DIXON WEST LINE: MILESTONE NO. 25 (CRUNSTONE) (27)
LOOKING NW TOWARD STONE (SE CORNER), MR. JASON CLOPER
& HIS FARM

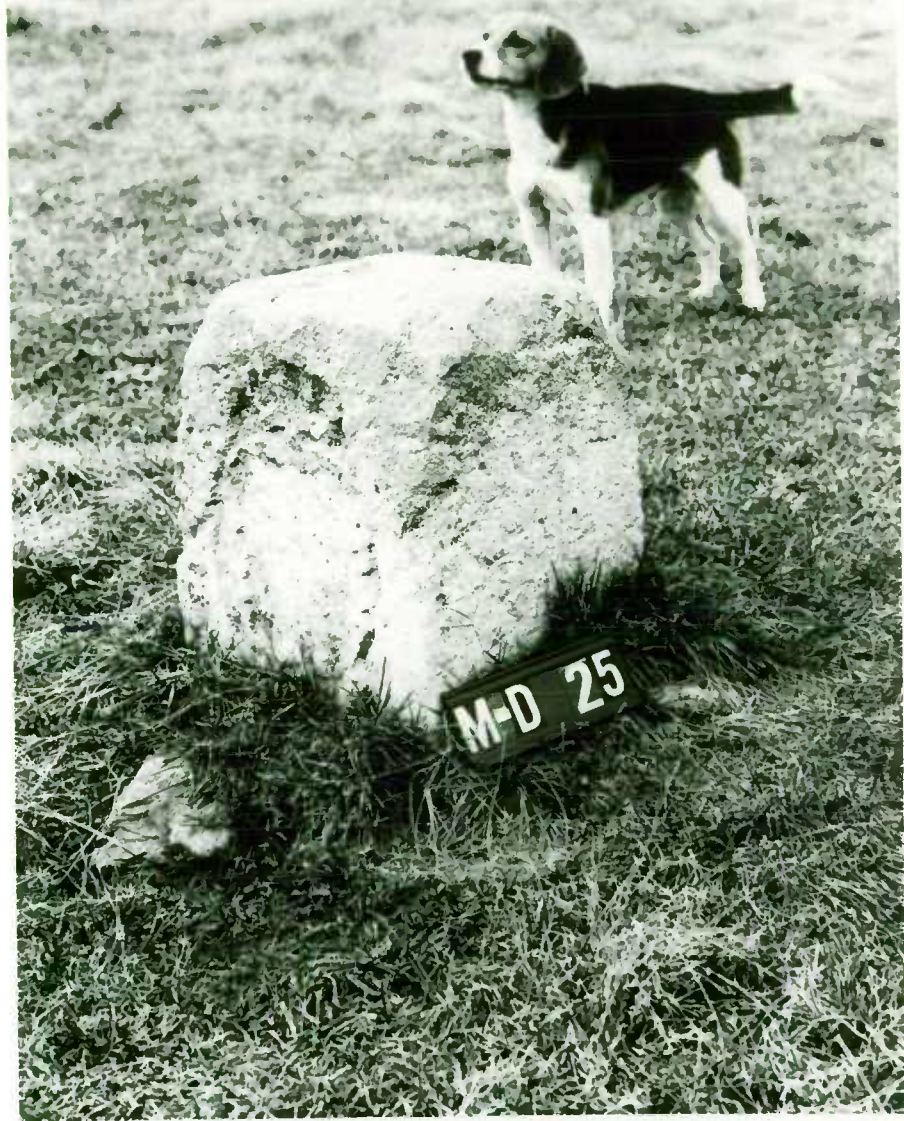
PHOTO: ALICE MARTIN 12/12/79 (A.E. 1979.13.5A)

E face: 11 1/4" wide x 12 1/4" high; no fluting or margins; chips all edges & corners;
badly weatherworn & scarred

S face (MD): 11 1/2" wide x 13" high; Calvert coat of arms barely discernible; no
fluting or margins; badly weatherworn & scarred; chips all edges

MASON & DIXON WEST LINE: MILESTONE NO. 25
(CROWNSTONE)

SOUTH (CALVERT COAT OF ARMS) & EAST FACES

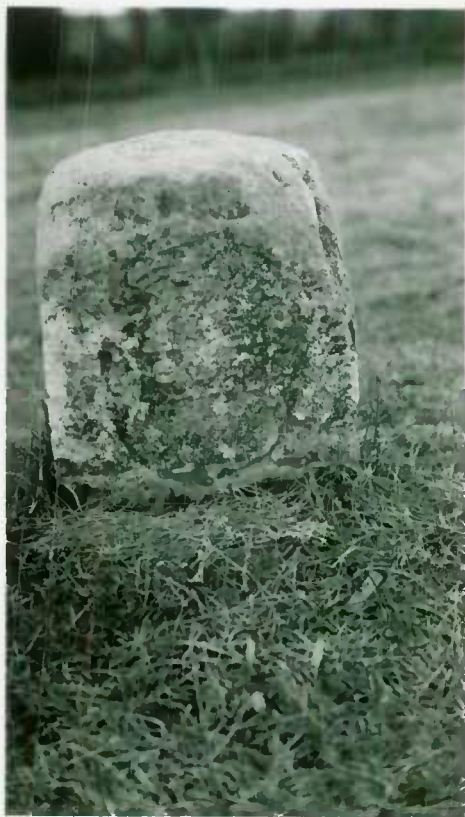
1026-8a
G. 5. 35
MED WEST LINE: MILES RE 2521
(CRONSTADT) 11/21/49

MS PENN CENT OF ARMS

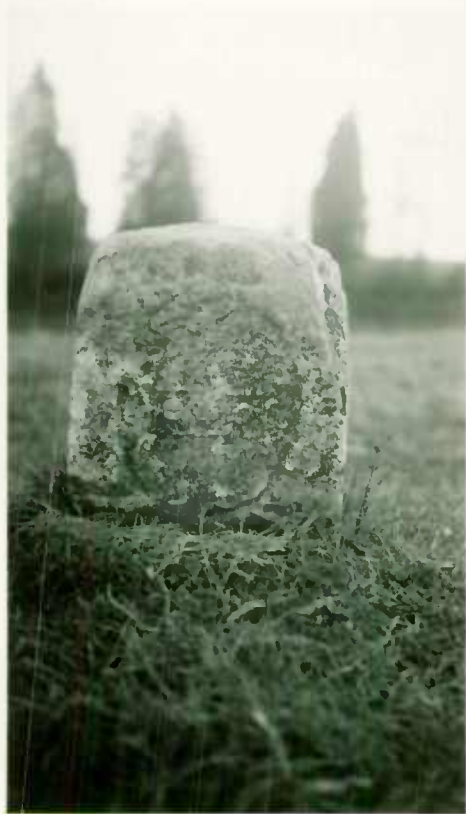
PP2-6.7a

MED WEST LINE: HILGROVE 25(27)
(CROWNSTONE)

N/S (PENN COAT OF ARMS)
